**Report of Findings**

**Parker (Catina) v City of Gulfport, et al.**

Fusion Engineering was asked to analyze and reconstruct an accident that occurred on February 1, 2020, where the driver of a GMC pickup truck was shot and killed by a police officer in Gulfport, Mississippi.

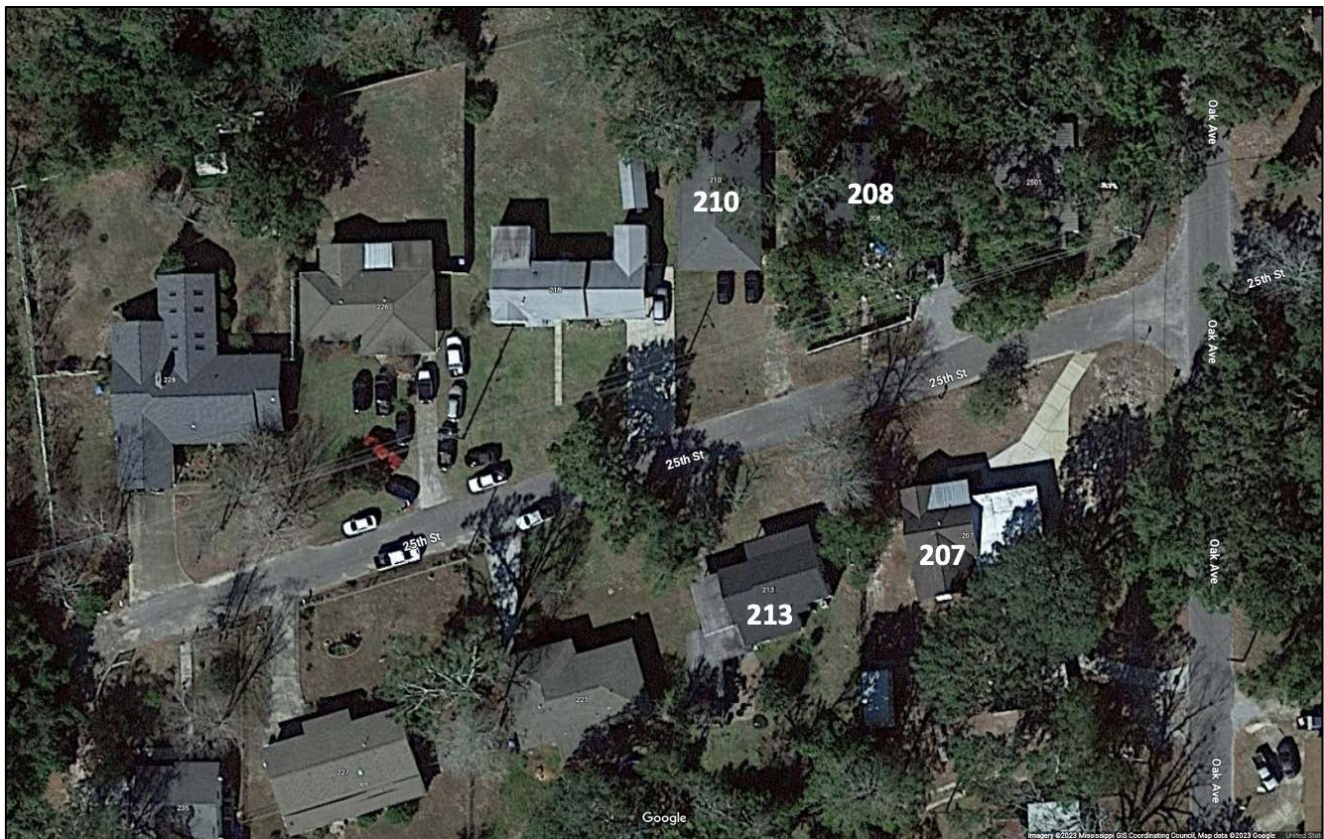
*Figure 2: Annotated Google Maps' Aerial View of 25<sup>th</sup> Street*

As shown in Figure 2, the east/west 25<sup>th</sup> Street is accessed by turning west from the north/south Oak Avenue and dead ends after 5-6 houses on both sides of the road. The subject truck was parked facing north in the front yard of 210 25<sup>th</sup> Street. The truck was then backed up in a southern direction before impacting the mailbox across the street at 213 25<sup>th</sup> Street. The impacted mailbox was located just south of 25<sup>th</sup> Street and just east of the 213 25<sup>th</sup> Street driveway. The impacted mailbox and 210 25<sup>th</sup> Street yard that the truck backed up from is shown in Figure 3. The vehicles shown in the driveway and yard of 210 25<sup>th</sup> Street were parked to the east of the path taken by the subject truck as it backed up. The red arrow in Figure 3 points to the disturbed dirt behind the mailbox post that is consistent with the mailbox deflecting rearward during an impact.

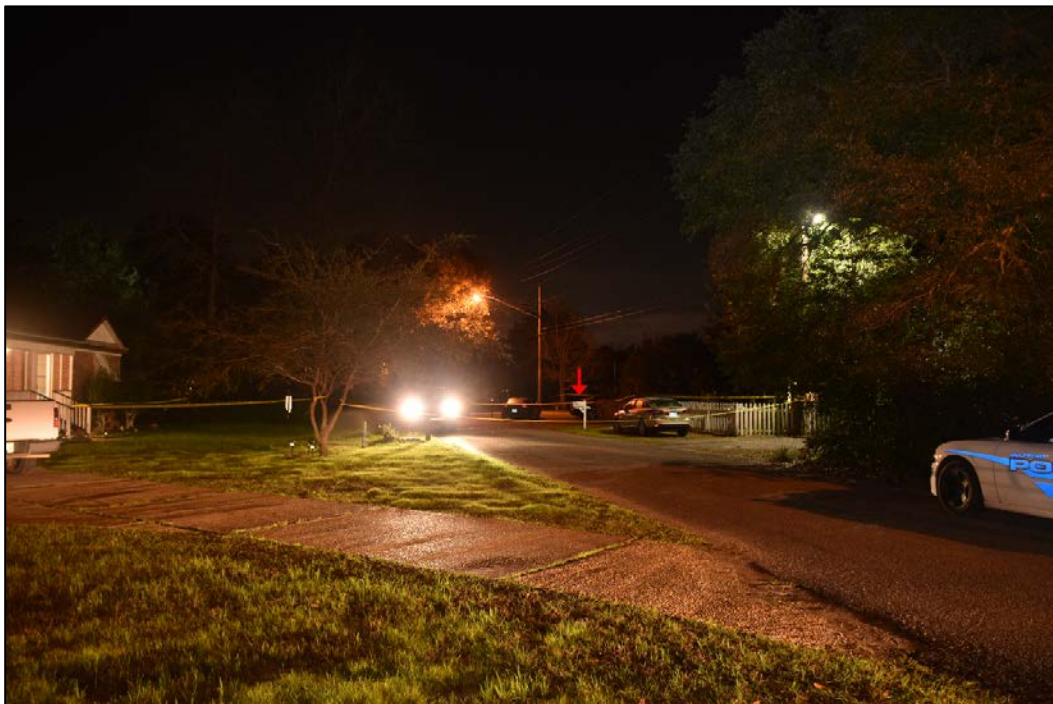
Figure 5: Annotated post-accident photograph (BLT\_0037) taken on February 1, 2020, at 6:23:12 a.m.

As shown in Figure 4, Officer Cuevas parked his vehicle on the north side of 25<sup>th</sup> Street across the street from the driveway of 207 25<sup>th</sup> Street. The red arrow in Figure 5 identifies the 208 25<sup>th</sup> Street mailbox that Officer Cuevas was walking towards when he noticed the truck backing up from the yard of 210 25<sup>th</sup> Street. Figure 5 also shows the parked location of Officer Cuevas' police vehicle and the headlights of the subject truck at its point of rest. As shown in Figure 6, the truck's post-accident point of rest is across the street from the 208 25<sup>th</sup> Street mailbox and just west of the western face of the 207 25<sup>th</sup> Street house.

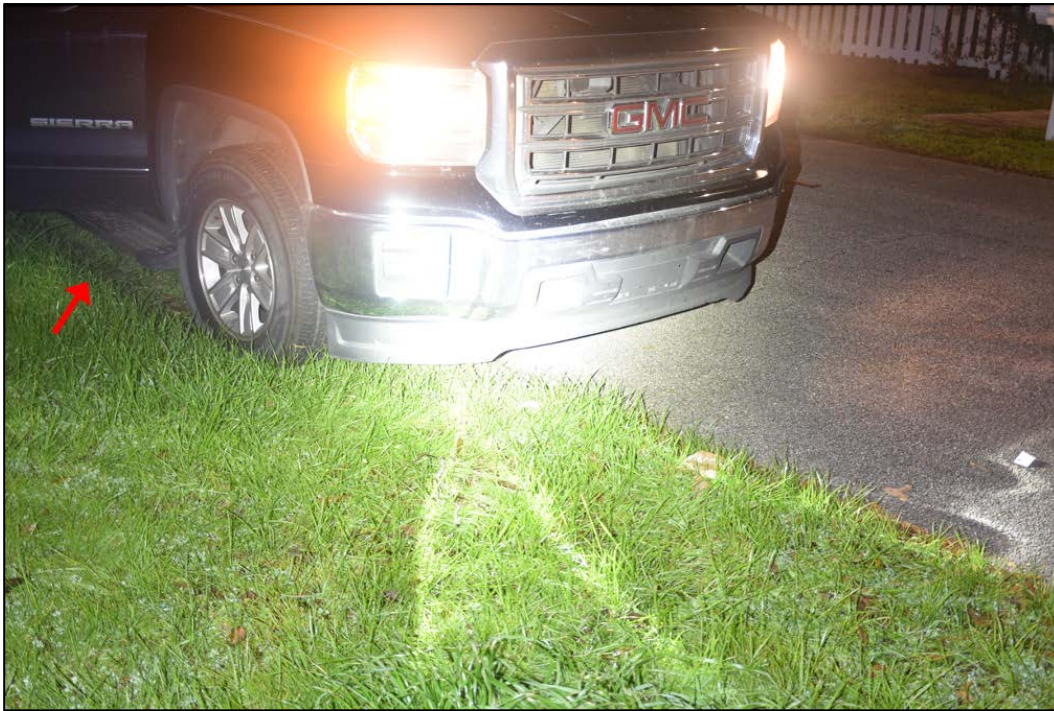
Figure 7: Annotated post-accident photograph (BLT\_0085) taken on February 1, 2020, at 6:35:24 a.m.

As shown in Figure 7 and Figure 8, the truck was traveling straight and approximately parallel to the road prior to coming to a stop. As discussed above, to get to the post-accident point of rest, Mr. Parker must have turned the steering wheel to the left and then allowed it to come back to center before coming to a stop. If he didn't do this the vehicle's heading would not be approximately parallel to the road at the point of rest. The physical evidence is consistent with Mr. Parker pulling over and bringing his vehicle to a stop and not consistent with a vehicle that only had a right steering wheel input after pulling forward from the mailbox.

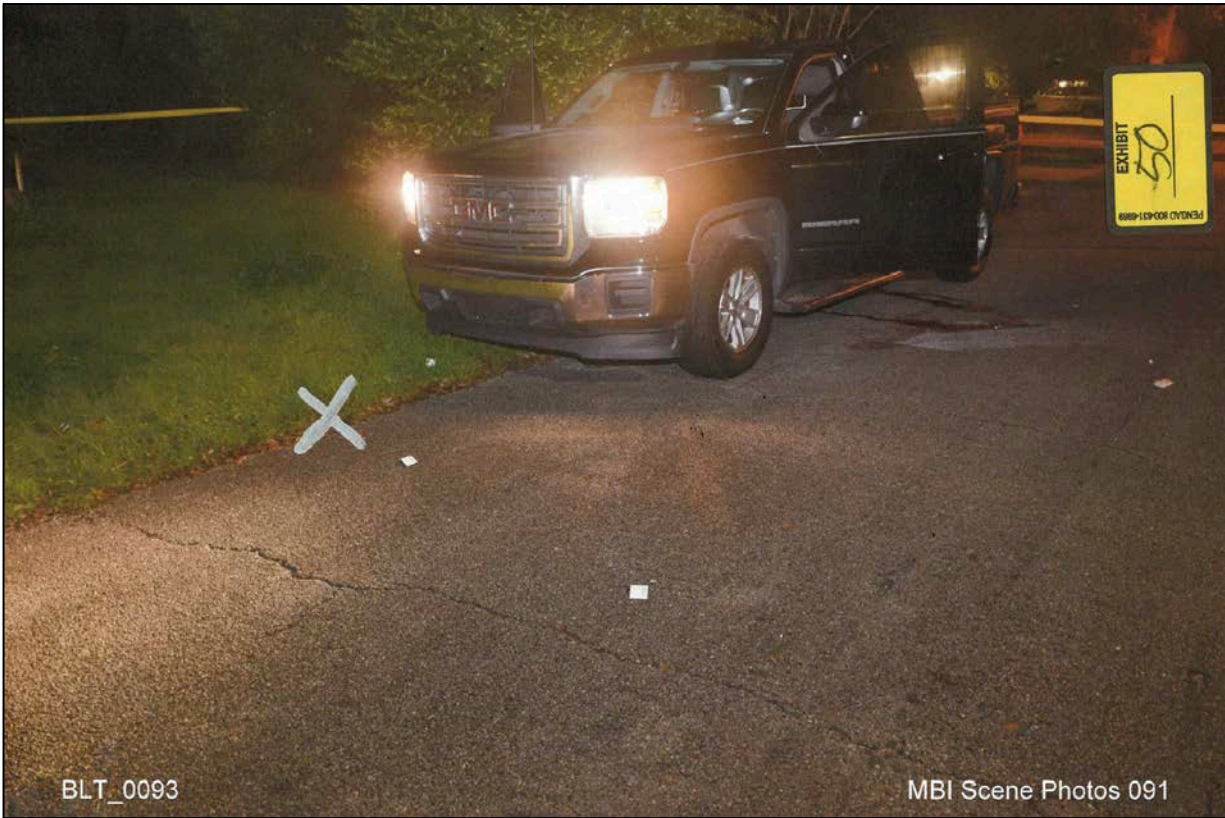
Figure 11: Ex. 50 of Jason Cuevas' deposition

- He was directly in front of the truck when he discharged his firearm three times in rapid succession between the 12 (police measurement of “*blood on ground near d/s door of suspect vehicle*”, which is to the north of the truck) and 3 (where he testified he discharged his third and final round in front of the truck) in ex. 49. He testified that he was at the location of the silver X in Figure 11 when he fired his third shot. According to this description he was moving in a southeast direction as he discharged his firearm in rapid succession.

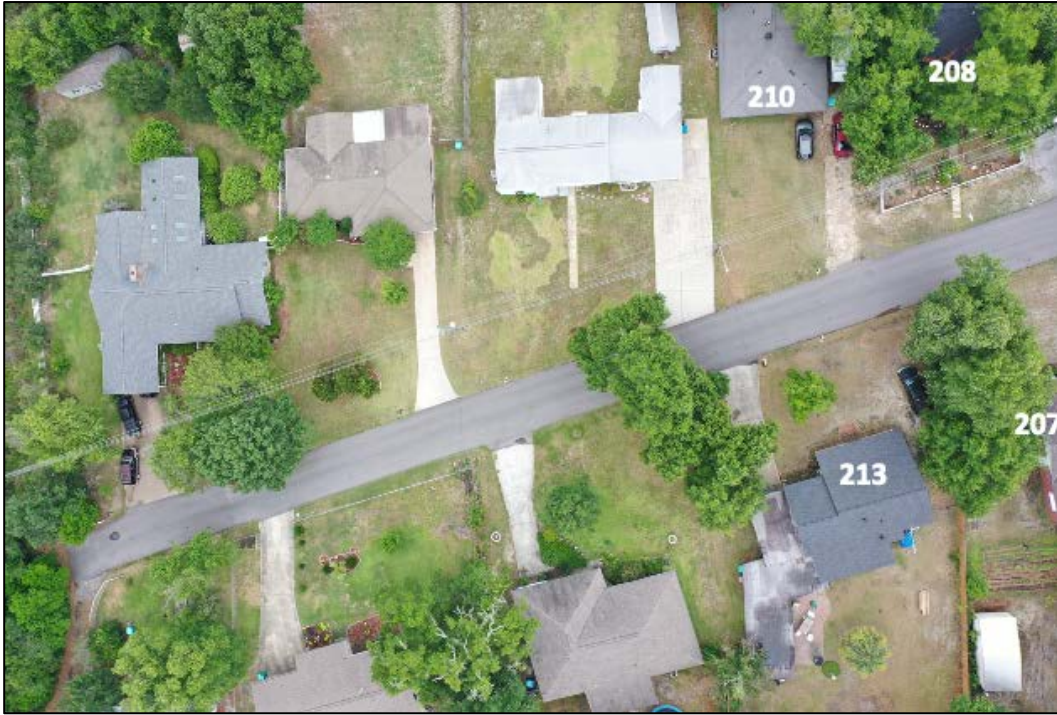
Figure 15: Annotated nadir aerial image taken during Fusion Engineering's June 15, 2023, Site Inspection

In addition to taking photographs from the ground, I utilized a DJI Mavic 2 Pro drone to capture aerial images. Figure 15 and Figure 16 are two of the aerial images that I captured during this inspection. To assist in surveying the scene, I utilized Propeller AeroPoints (GPS pads) as ground control points. I later processed the aerial images and ground control point within Pix4D Mapper and generated a 3D point cloud of the site (Figure 17) and an Orthomosaic map of the site (Figure 18). During the inspection I also laser scanned the site with a Faro Focus S350 laser scanner. This allowed me to capture the geometry at the ground that was blocked by the tree foliage. The methodology and tools I utilized to survey the accident site are commonly used by accident reconstructionists to accurately capture the 3D geometry of an accident site.

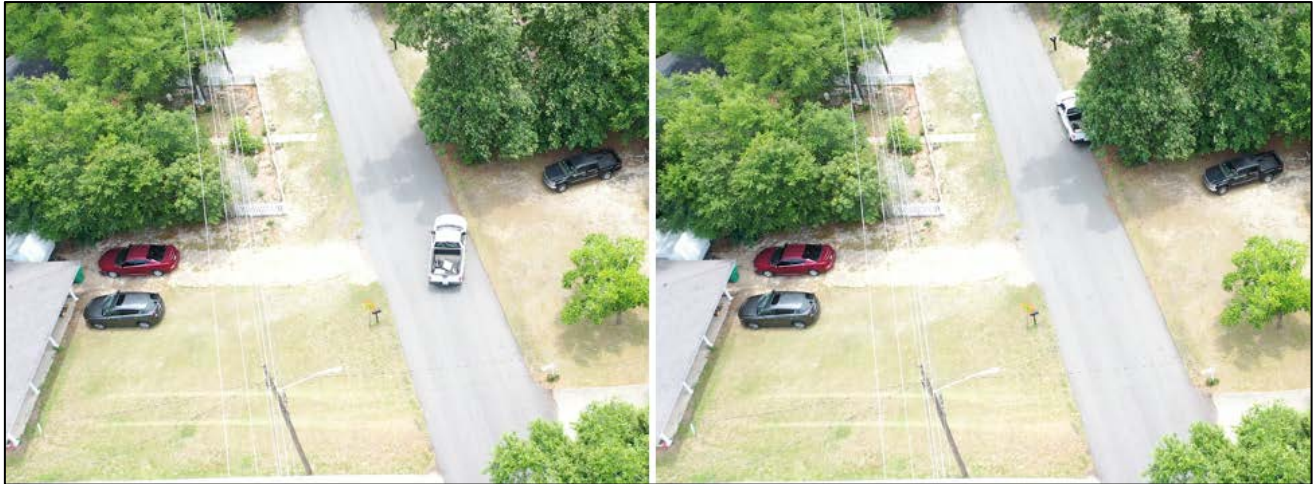
*Figure 20: Run 5 from Fusion Engineering's June 15, 2023, Site Inspection*

I drove a 2019 Ford F-150 truck bearing the VIN 1FTMF1EB7KFC49332 to the inspection. This truck had a 122-inch wheelbase, a 20.4 foot turning radius and a curb weight of 4,343 lbs. The truck was four wheel drive, but I left it in 2H (rear wheel drive), to better match the drivetrain of the subject truck. During the inspection I drove the approximate route taken by Mr. Leonard just prior to the shooting to demonstrate the steering wheel inputs required to arrive at the point of rest from his starting position near the mailbox at 213 25<sup>th</sup> Street. I started in the yard of 210 25th Street (left side of Figure 19) and backed up until the right rear corner of the truck was just past the mailbox at 213 25th Street (right side of Figure 19). I then drove forward and turned the steering wheel to the right to head east on 25th Street. I continued to input the right-hand turn until the truck was no longer parallel to the street and was heading southeast towards the south side of the street (left side of Figure 20). In order to end up with my right side tires in the grass and the vehicle approximately parallel to the street, I had to turn the steering wheel to the left and then allow it to come back to center before coming to a stop at the approximate post-accident point of rest (right side of Figure 20). In order to come to a stop at the point of rest, I had to apply my service brake. After I brought the vehicle to a stop at the point of rest, I released the service brake, and the vehicle began to slowly roll forward. On the day of my inspection the grass and ground were dry near the point of rest.
